COASTAL EROSION ON THE ISLAND OF BHOLA, BANGLADESH

Magnus Krantz

**Department of Physical Geography
GÖTEBORG 1999**

B178
Projektarbete
Göteborg 1999

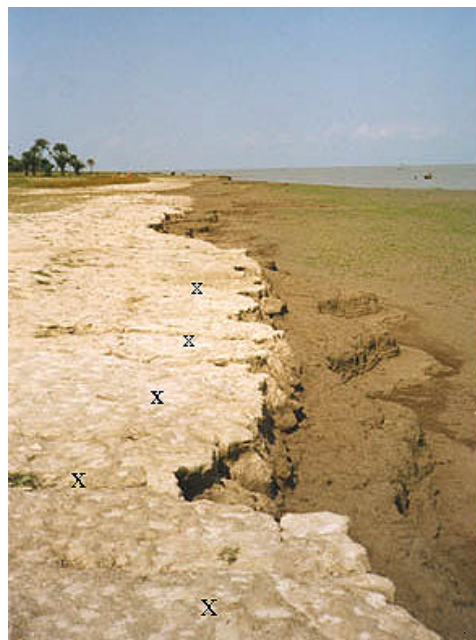
X= Measurementstick

Figure 8: Example of a measurement station
Photo: Magnus Krantz 1998

One interesting area at the east coast of the northern part of the island of Bhola was found and four different stations were made to measure the erosion. The best way to measure erosion was to have an exact distance between the coastline and a fixed point a short distance onshore. To calculate the erosion, a stick was placed in the ground exactly 100 centimetres onshore from the edge of the water. This was made in an area of 50 metres with 5 metres between each stick (figure 8), so there were 10 measurement points at every station. Four different stations with a distance of at least 500 metres between each other were created. In this way, more than 2 kilometres of the coast were covered. Observations were made once every day at these stations. The calculations took place during a 24-day period.

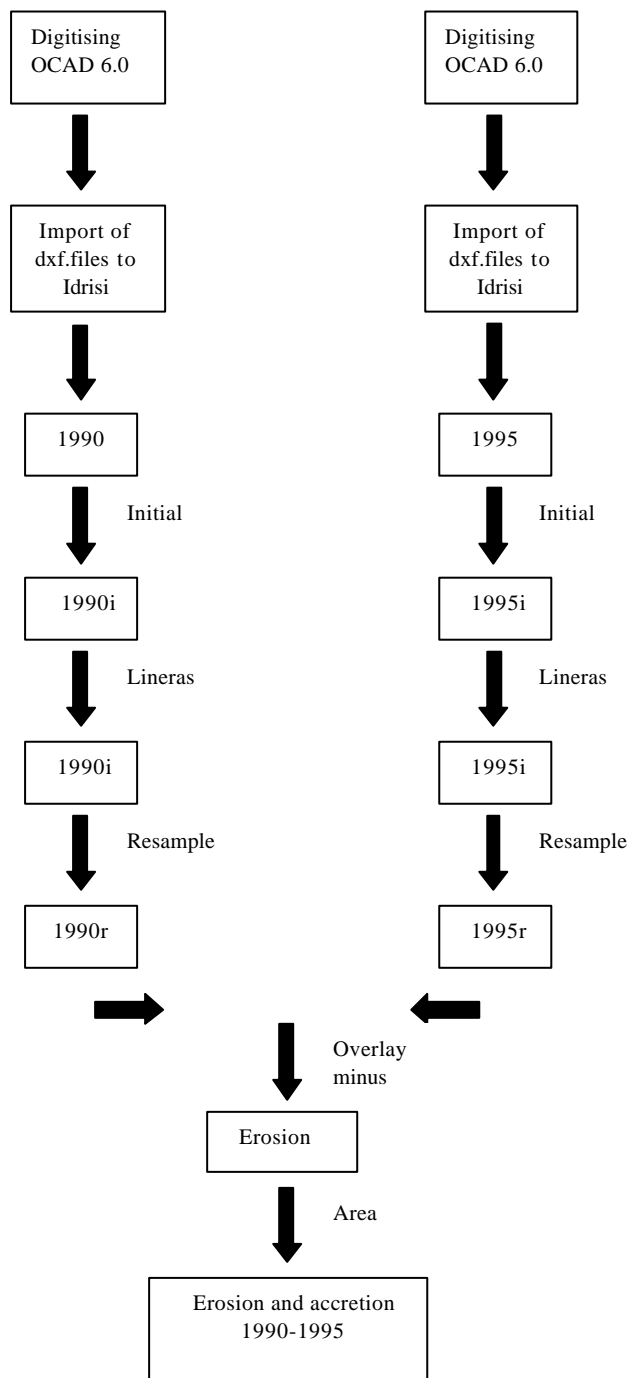
This flowchart shows the GIS-operations made to calculate the erosion from satellite images from January 1:st 1990 and February 6:th 1995. To do these calculations, the software “Idrisi for Windows” has been used. A drawing was made of the images, because they had no proper coordinate system. The only way to match them together was to use the big river in the middle of the images. This way to work is not as exact as working with digital data, but this was the only way to work with these images. Depending on the digitising operation, some small mistakes can occur. Mistakes that may occur are due to line size during the drawing operation and skilfulness by the person who is digitising.

DXFIDRIS transfers vector data between IDRISI for Windows and DXF formats.

INITIAL creates a new raster image with the same user-defined value in each cell.

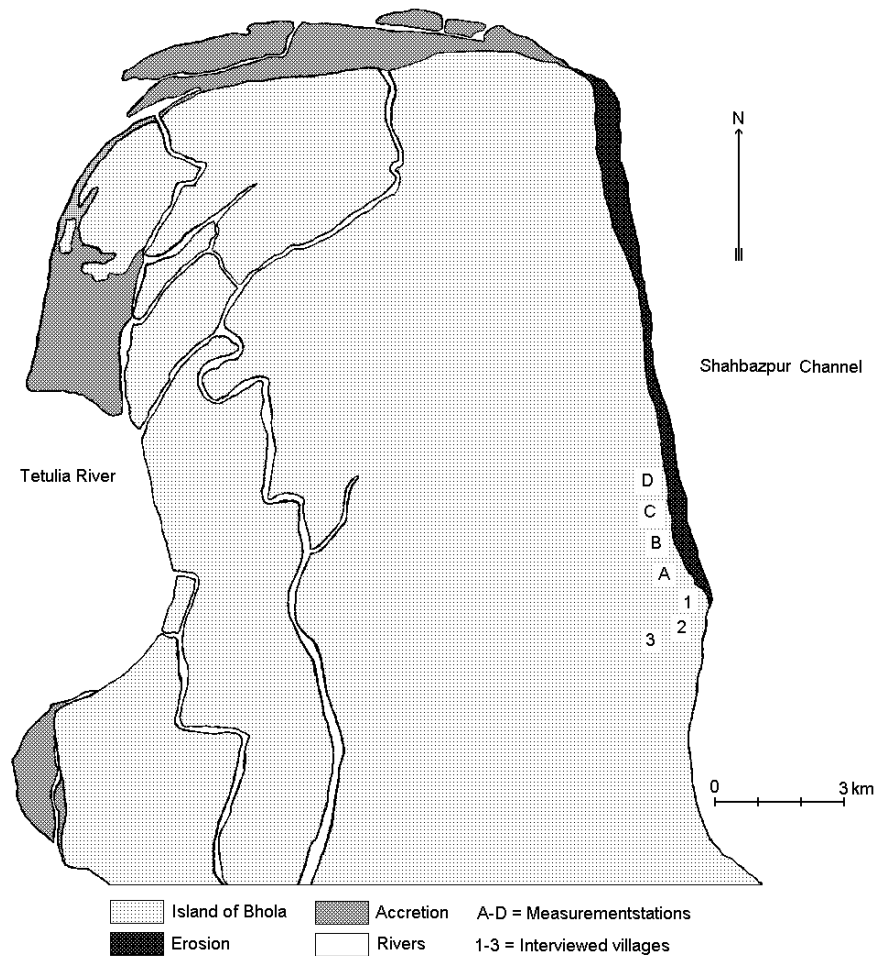
This part is based on satellite images during a period of five years. As basis for these calculations, Landsat TM satellite images have been used. The images are from two different years, 1990 and 1995. These images are bought from SPARRSO (Bangladesh space organisation) and are in the scale of 1:100 000. The images have been digitised in OCAD 6.0 and calculated in Idrisi for windows. The results show that the erosion has been big at the east side of the island of Bhola. At the west side and in the northern part of the island, the accretion has been big.

Figure 13: Shows the erosion, the accretion and the total landmass in an area of the northern part of the island of Bhola between 1990-1995.

24 points at the map were measured and a calculation was made. The purpose of this was to find one maximum, one minimum and one average value for the erosion during this 5-year period. The **maximum** value was 600 meters in a period of 5 years, this gives an annual erosion of **120** metres. The **minimum** value was 130 metres, which gives an annual erosion of **26** metres. The **average** value was 342 metres and gives an annual erosion of **68.4** metres.

According to the area, the erosion was **4.3 km²** at the east side of the island of Bhola between 1990 to 1995. Siddiqi et al found that the erosion at the east coast of Bhola was about 3.5 kilometres between 1940 to 1963 and 3 kilometres between 1963 to 1982, (figure 5). Their study was made over a period of 19 years and this gives an annual erosion of 152 (1940-1963) and 158 meters (1963-1982).

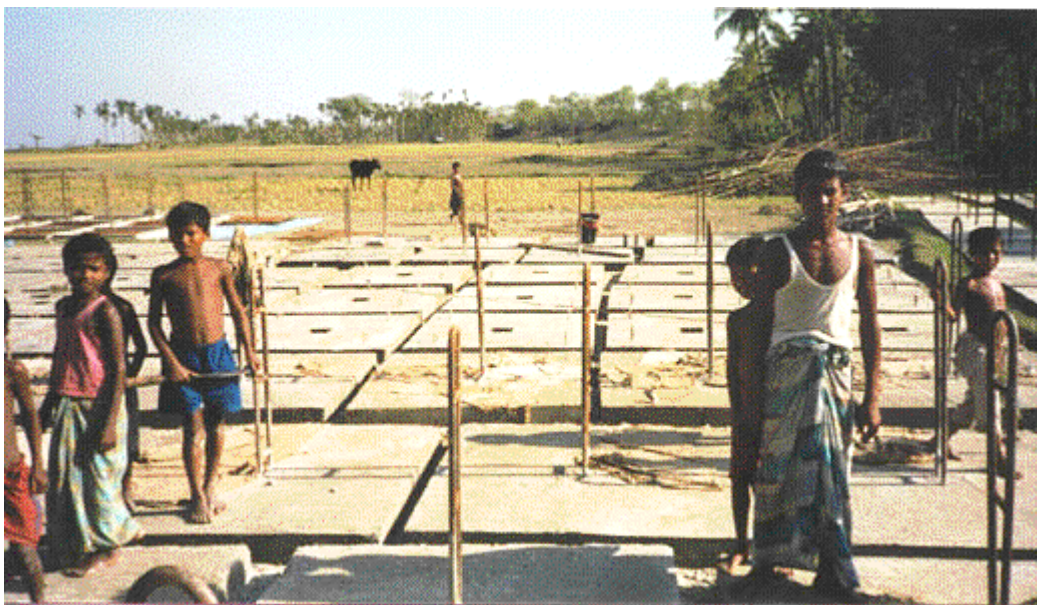
In present time, a Dutch company (DEFT) is working on a new solution to try to stop the erosion at the Northeast coast of the Island of Bhola. They are building reinforced concrete plates that shall stabilise the coast and protect it from riverbank undercutting, (figure 15). These plates are about 100*100 and 10 centimetres thick, and armoured into the ground to stabilise and protect the ground from erosion. The local engineer did not believe in this project, he thought that Meghna (the Shahbazpur channel) was too strong for this construction. It seems like this solution is a really short-time solution. The erosion is 68.4 metres every year, and in 5 years this place will be under water. The currents will undercut the concrete plates and sweep it away out in the river.

Figure 15: Shows the reinforced concrete plates that DEFT are building.
