The Craftsmanship in Construction and Transformation of Historic Tower Campaniles

Mattias Hallgren¹ and Gunnar Almevik²

1. Independent Building Researcher; 2. University of Gothenburg, Sweden

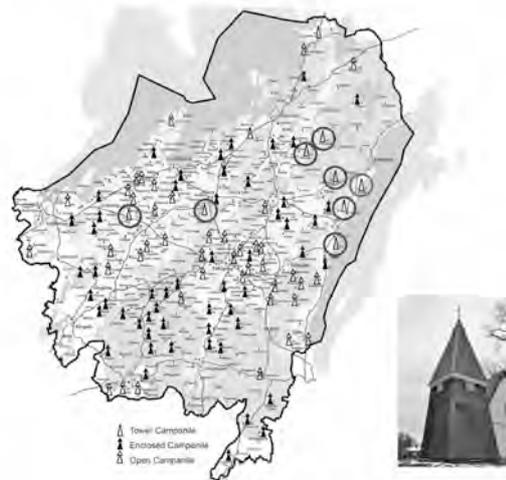
Figure 1. Mapping of campaniles in the diocese of Skara. Grevbäck is marked with a red ring. It is provisionally dated to AD1303 but further dendrochronological analysis is in progress. Dated by dendrochronology are also: Brevik AD1321-1336, Norra Fågelås AD1360, and Ransberg AD1383-1407. St. Levene, Marum, Vad and Ekeskog are considered to be medieval constructions. Illustration by Elisabeth Orebär Krantz.

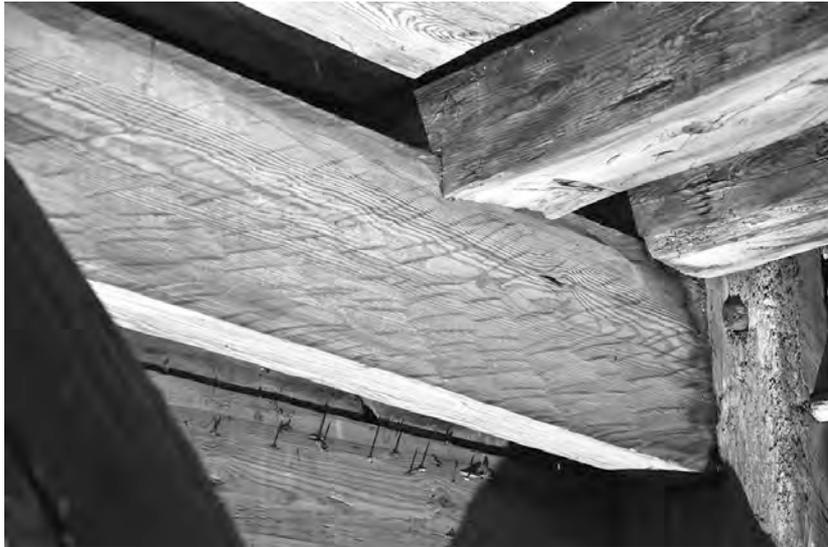
Figure. 6. Toolmarks from the particular hewing technique sprättäljning.

All the material that is considered primary is hewn in a particular technique, known as *sprättäljning*. The work process of hewing in parallel or diagonal bands along the wooden fibres is significant in mainland Sweden before the Black Death in the late fourteenth century.[14] The clamped sill that is considered secondary, has marks from a broad axe cutting the fibres in a perpendicular angle. Another significant quality of the original construction material is the boxed shape and the sharp edges. This quality is consistent and must have been a norm in the historic building process. The dimensions, however, vary from base to top and within the same type of construction material. The edges are always sharp but the profile may be rhombic and the surfaces concave.

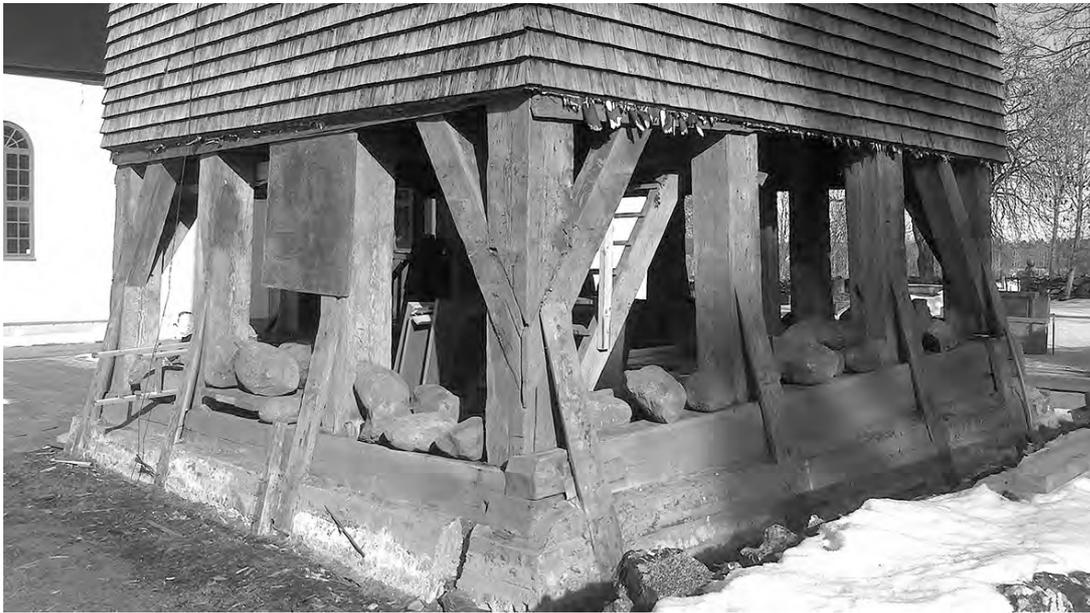
Figure 7. Ransbergs tower campanile. The secondary clamped sill with inner and outer plates.
